**DEPARTMENT OF CONSERVATION AND NATURAL RESOURCES  
DIVISION OF WATER RESOURCES**

Re: Yerington Mill (NV00144)

On December 11, 2015, Edmund Quaglieri P.E., and Colette Easter, P.E., inspected Yerington Mill Dam. The purpose of the inspection was to determine the condition of the structure with respect to dam safety. The Yerington Mill Dam is classified as a **significant** hazard dam due to downstream development or activity.

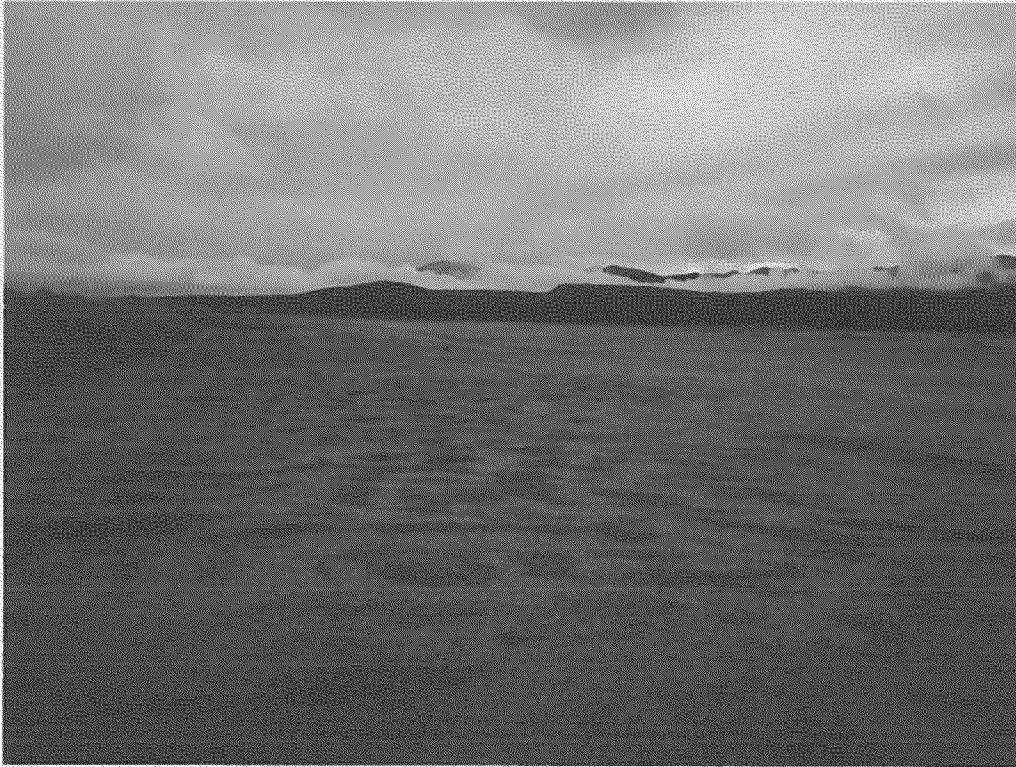
Yerington Mill Dam; General condition of the dam. Capped in place with dense grade and clay. Test pits throughout the cap were noted during inspection.

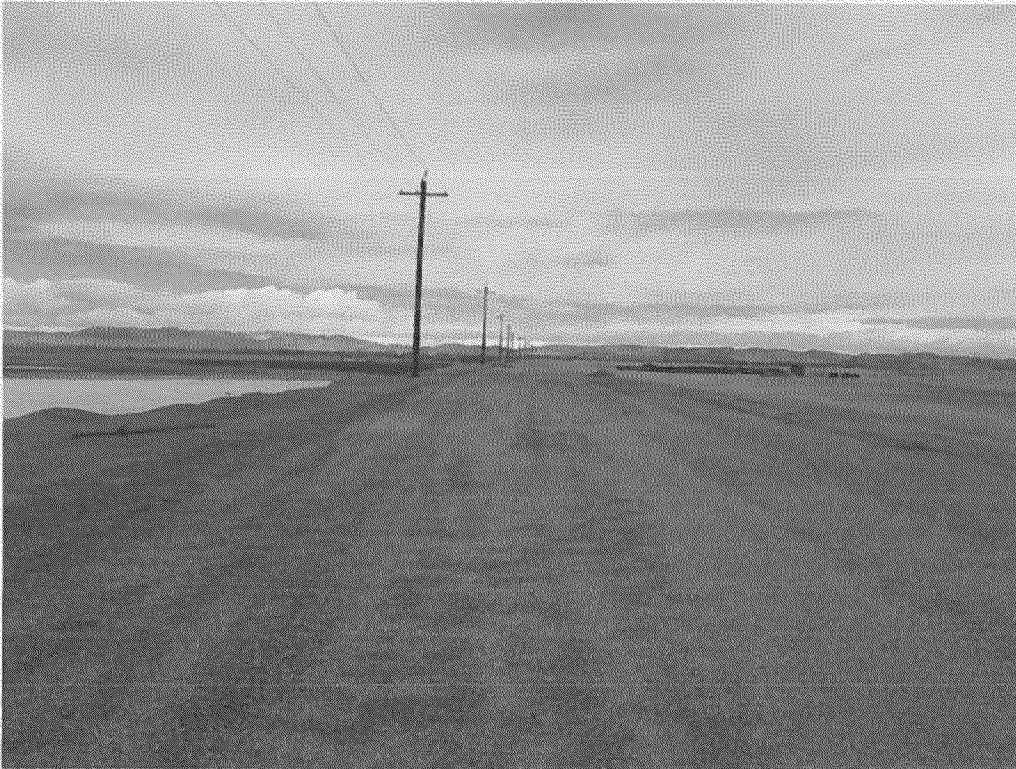
Yerington Mill Dam; General condition of the crest of the dam. Power lines run along the north crest/access road.

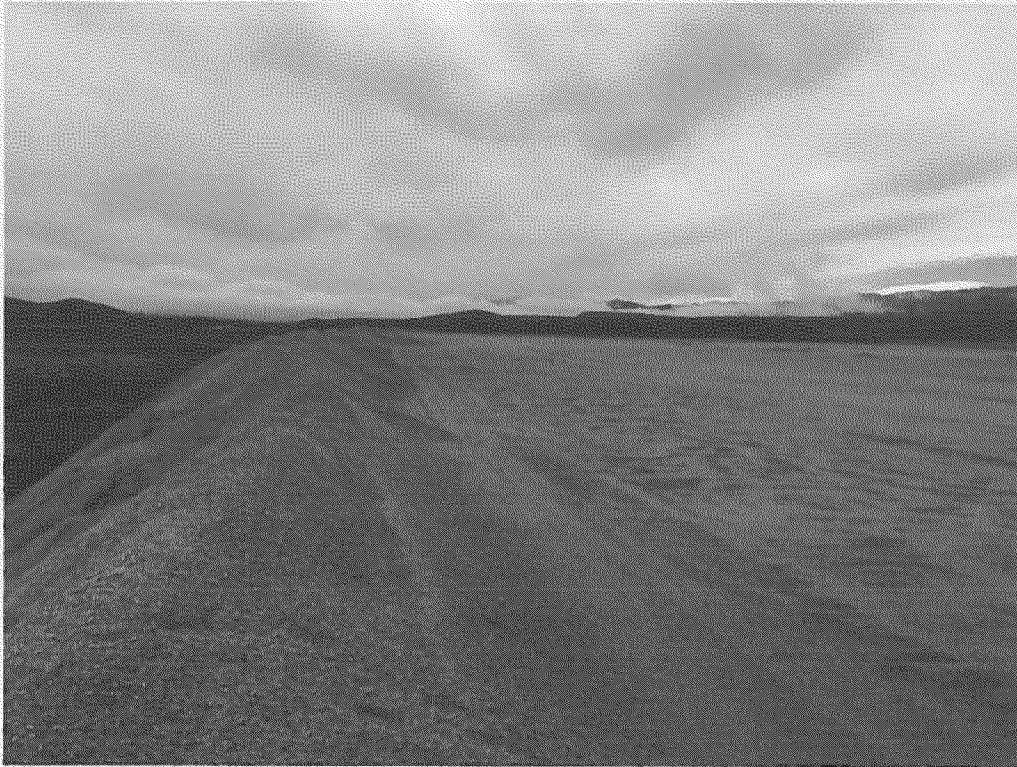
Yerington Mill Dam; General condition of the south and east crest. Some evidence of stormwater erosion predominantly along the downstream face of the embankment.

- 1) Debris and trash is currently being stored on the capped surface of the dam. This should be removed to ensure the debris does not impact the integrity of the capping material or impede drainage.
- 2) Ruts and gullies on downstream and upstream faces should be filled in and a camber established on the crest to encourage even runoff.

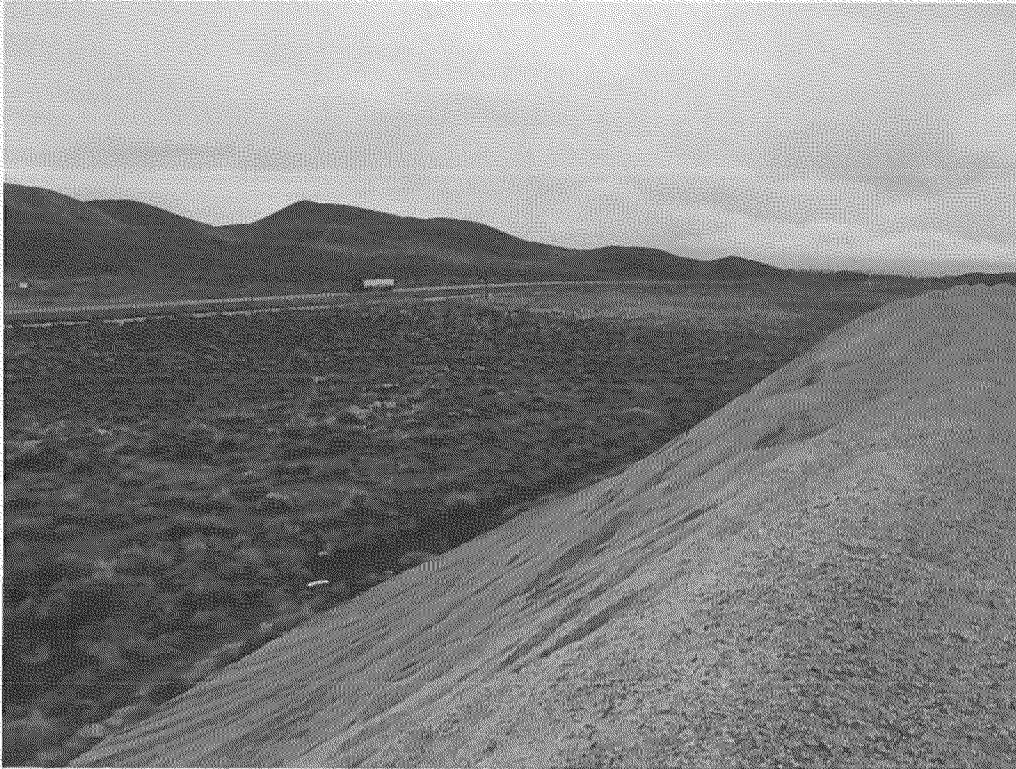
Yerington Mill Dam; Downstream face of the embankment has significant riling most likely due to stormwater runoff.

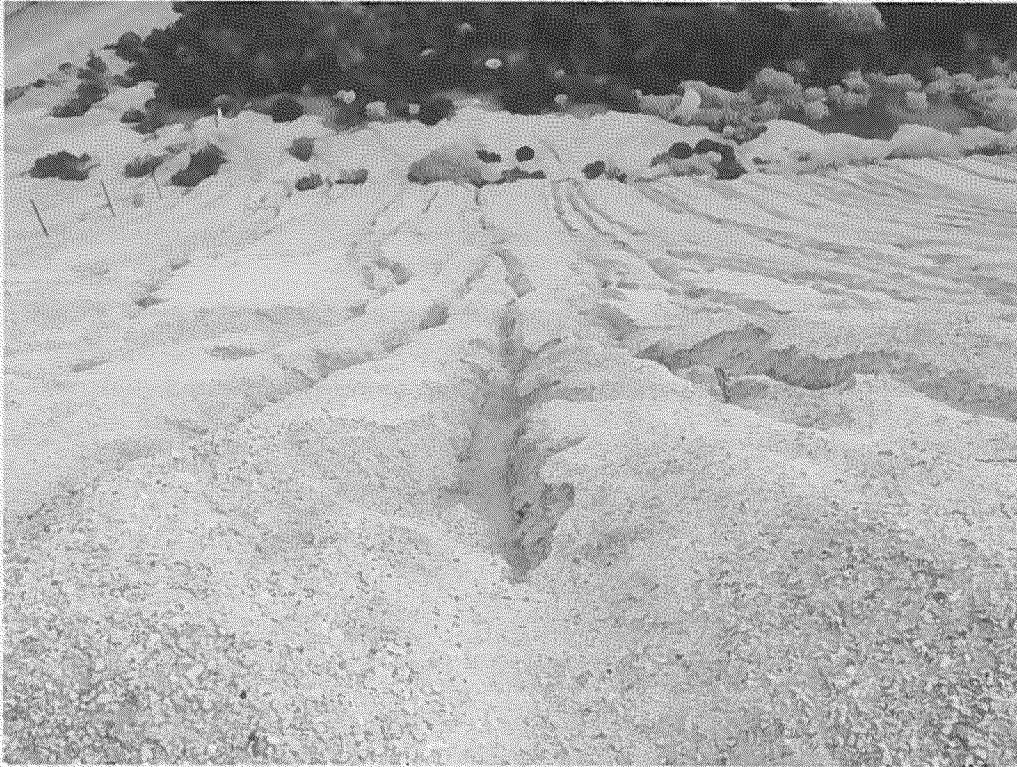
Yerington Mill Dam; Downstream face of the embankment has significant riling most likely due to stormwater runoff.

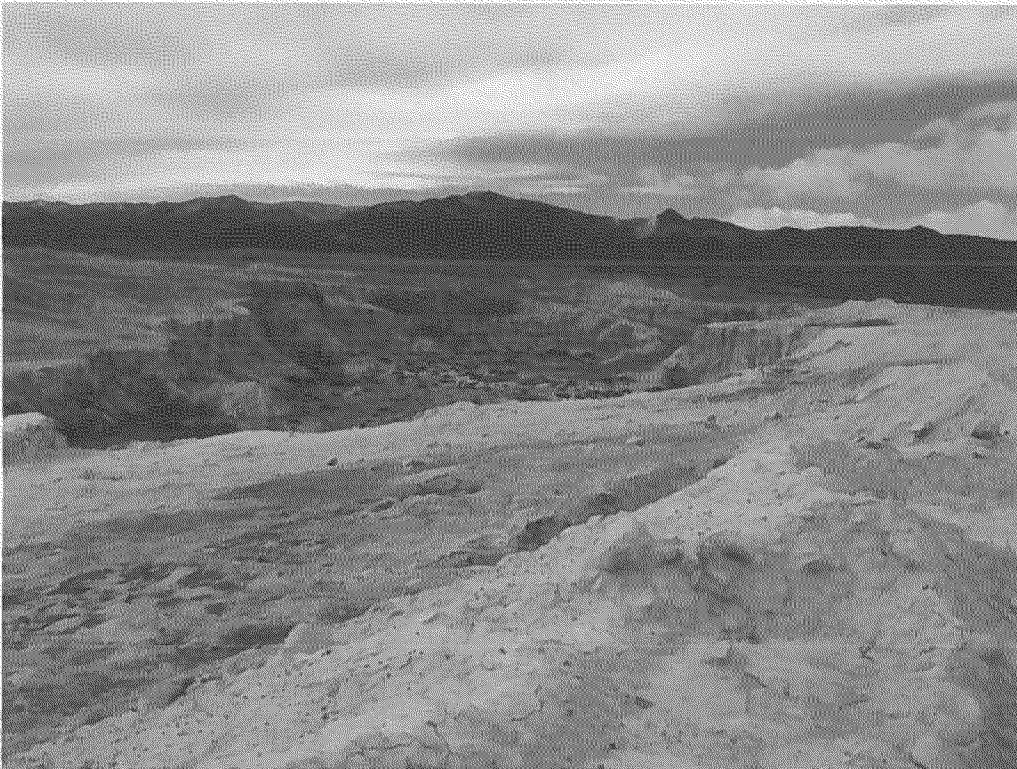
Yerington Mill Dam; There appears to be an unmaintained stormwater infiltration area near the north east edge of the facility. This area should be monitored to ensure ponding does not occur or uncontrolled flow paths from the detention area through the embankment are not established.

- 1) The areas of unmaintained stormwater detention and infiltration, which can be found at the Northeast portion of the facility, should be monitored and maintained by the owner to ensure uncontrolled flow paths created by stormwater are not developed.

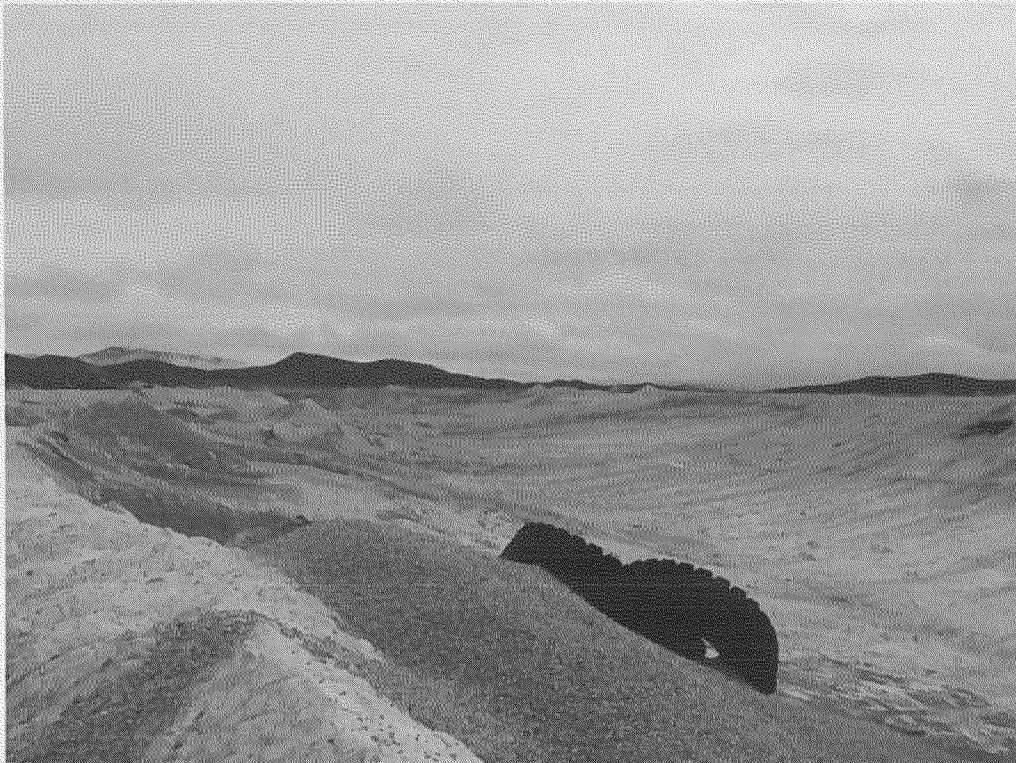
Yerington Mill Dam; There appears to be an unmaintained stormwater infiltration area near the north east edge of the facility.

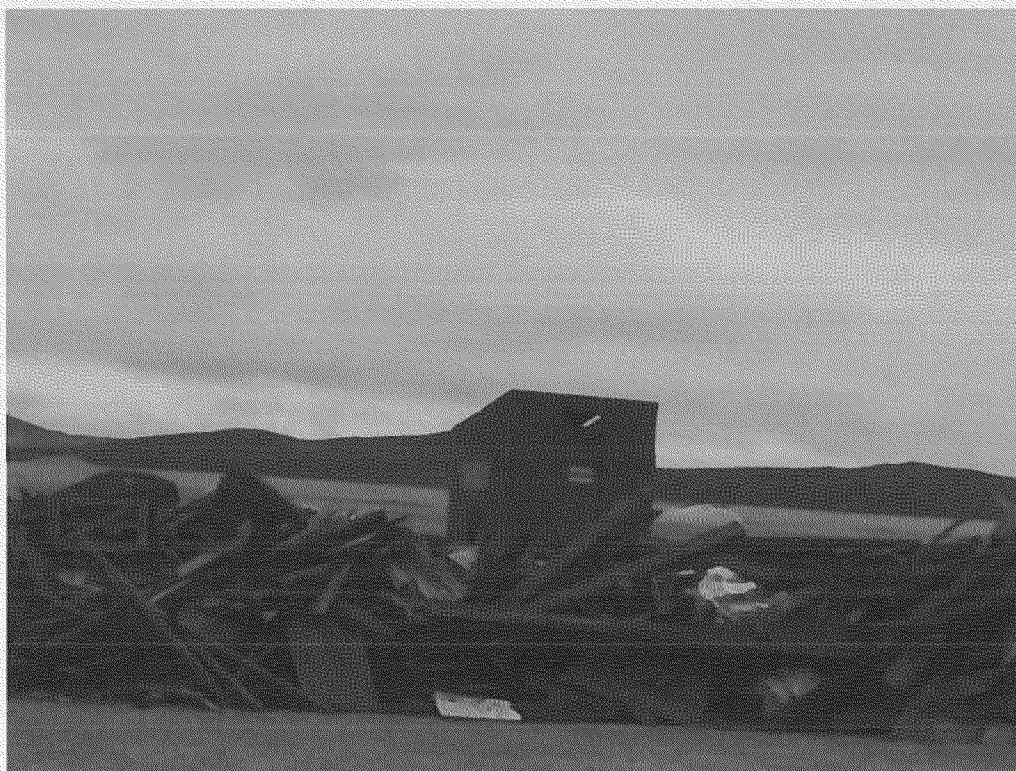
Yerington Mill Dam; Areas of debris and trash should be removed from the cap.
